# Thermographic boundary layer visualisation of wind turbine rotorblades in operation

<sup>1</sup>Bremen Institute for Metrology, Automation and Quality Science; <sup>2</sup>Deutsche WindGuard Engineering GmbH WindGuard

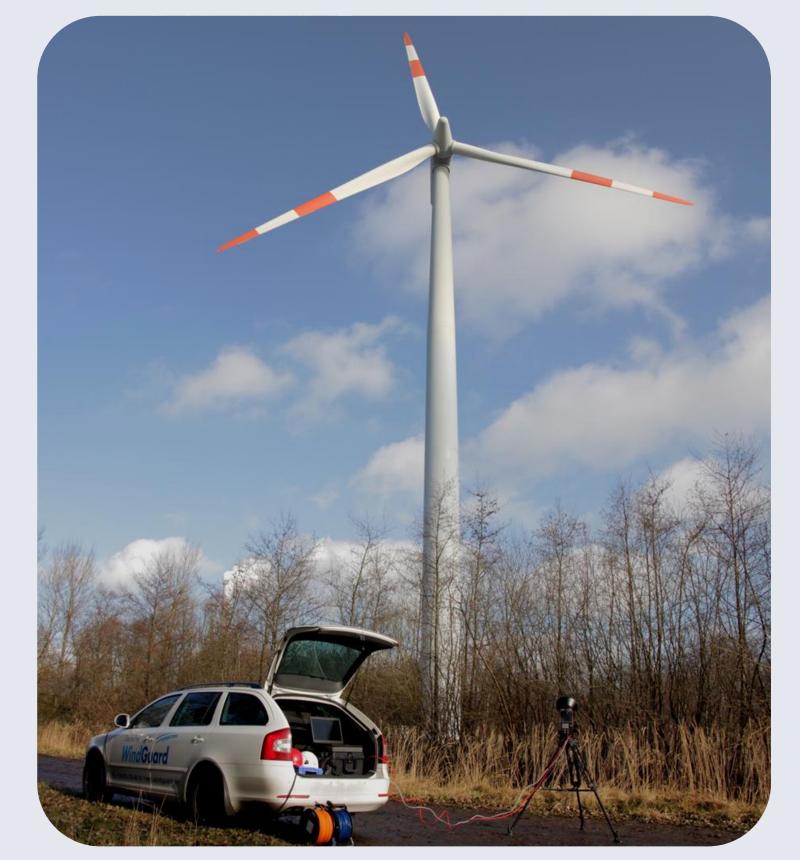
Fig. 2: Measuring setup

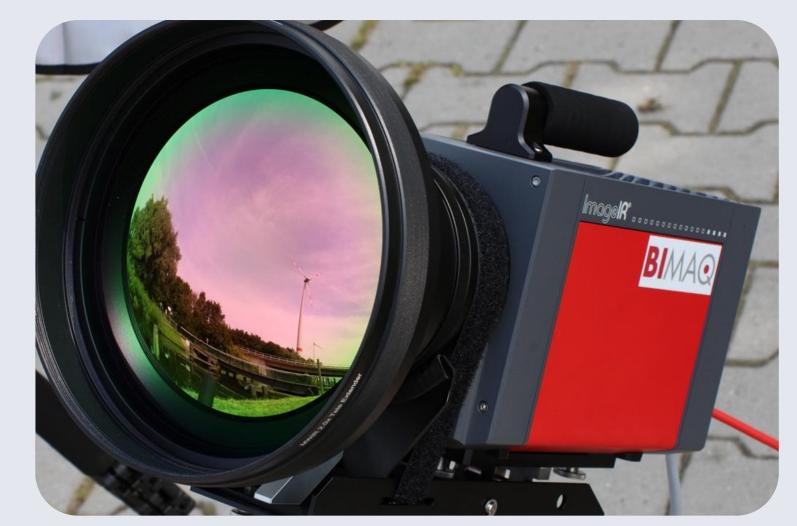
Fig. 5: Thermographic imaging system with telephoto lens.

Tip speeds of 75 m/s require fast shutter speeds (short integration times) to reduce motion blur. A high speed actively cooled 640x512 pixels InSb-focal-plane-array with a thermal resolution better than 0.025 K is used together with a telephoto lens (Fig. 5) to acquire high resolution thermal images of rotorblades in operation.
